Number, volume of Water Tanks: There are two water tanks, one fills about 500.000 gallon of water, the other about 670.000. The tanks are connected by an insulated pipe and operated by a water plant.

The collecting system from the river to the tank: There is a cement block anchor in the river where water is taken upstream and about 2½ miles hard pipes which is currently lost to the river. When not used the pipeline is usually stored 2m above ground on a carrying structure along the coast line of the river:

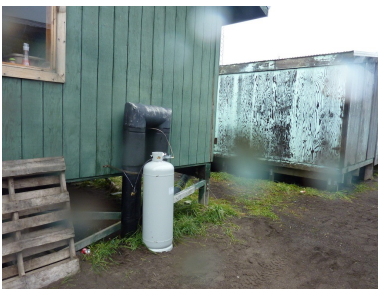
On-site in Kivalina you also find a pipe system connected to some of the housing units:

It was not possible to find any information according to these pipes.
